The Rehabilitation and Future of the "Pink House" (7137 Main Street)

Bottom Line Up Front: The Town of Clifton is currently evaluating a proposal to conduct safety-critical renovations on the "Pink House" (7137 Main Street) and convert it into a permanent municipal hub. This proposed path forward relies on a \$500,000 grant to cover the majority of the \$632,025 estimated cost. The Town accepted the grant in August 2025 and proceeded with the design phase of the effort. The Town has now received the full cost estimate and has to vote whether to proceed with the construction phase of the project. If the Town proceeds, it would gain a long-term administrative base but must agree to strict 20-year binding conditions, including a total prohibition on commercial leasing and a mandate for public-only parking.

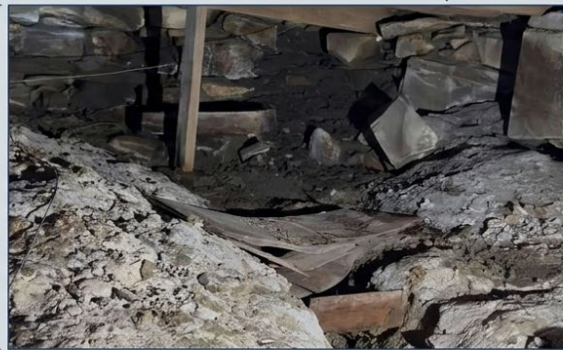
Antiquated Foundation

Existing stone foundation walls are failing. Stones are loose, displaced by water, and lack adequate mortar or concrete reinforcement.

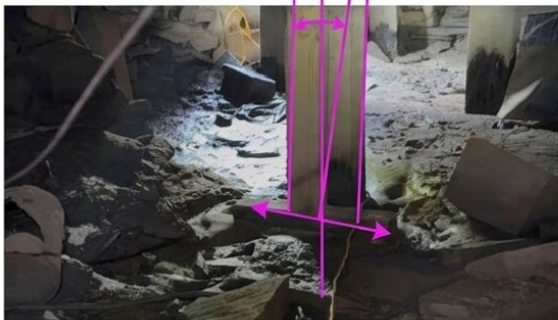
Leaning Columns

The internal support systems are failing. "T-braces" were found buried in mud with rotted bases; because these braces support three to four floor joists simultaneously, any shift in the mud compromises a significant section of the floor. Several structural columns are leaning severely and, in some locations, are no longer touching the joists they were intended to support. The floor is currently being held up by rotted 2"x2" ledger boards relying on the sheer strength of antiquated nails.

Structural columns in the crawl space have rotted bases and are leaning severely. The main support beam is installed flat, reducing structural strength.

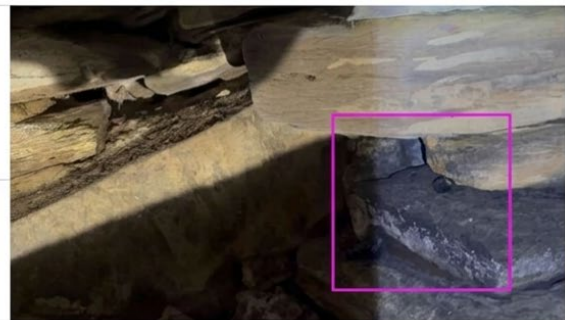
The Sagging Hearth

A massive concrete hearth was poured directly over the hardwood floor with no bracing. Supported by a cracking stone pier, the floor sags up to 2 inches.

The first floor exhibits a dangerous 1.5"-2" sag. This was caused by a concrete hearth being poured directly over original hardwood flooring without structural bracing. This "slab-on-

hardwood" installation at mid-span, combined with the rotted ledger supports at the end-span, creates an imminent risk of floor collapse.
